J. ARONSTEIN

HAZARDOUS FPE CIRCUIT BREAKERS AND PANELS

(Updated as of May 25, 2007)

Information for Inspectors and Homeowners

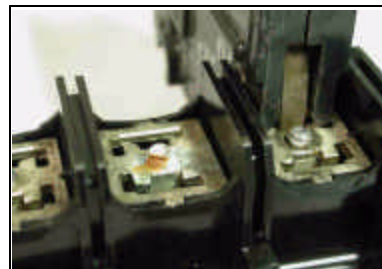
C. Stab socket on a post, attached with an 8-32 steel screw.

Of the three types illustrated, the one shown in Figure 2-C is known to have a high probability of deteriorating and overheating of the stab socket structures when subjected to significant current flow. Each individual stab socket plate is connected to its bussbar via a post (spacer), and the assembly is held together by an 8-32 steel screw. FPE panels with this construction are prone to overheating failure. The seven panels of the present study that showed evidence of serious overheating were constructed this way. One example is shown in Figure 3.

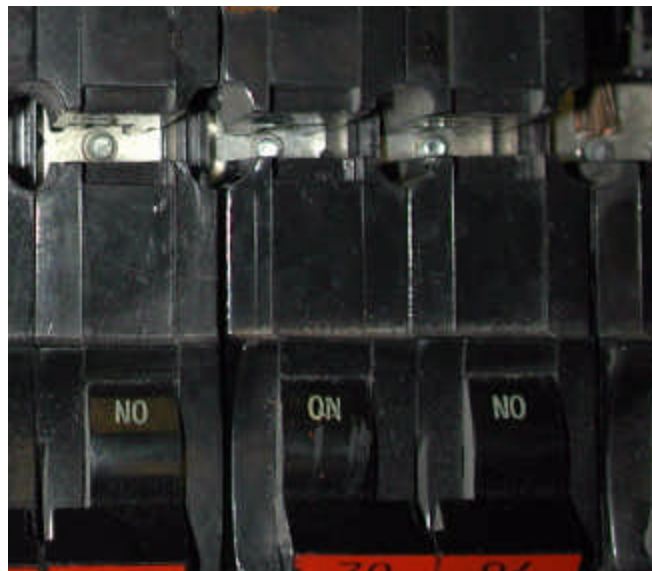
Inspectors can, however, determine if a particular FPE panel has this type of construction, and, to a limited extent, whether it has failing bussbar interconnections that have previously overheated. With the panel cover off, for this type of panel, you can see the ends of the screws holding the stab socket plate as shown in Figure 5. (Note: If you see slotted screwheads, that's a different type of panel construction.) The stab socket plates and the visible ends of the screws should have a bright metallic look. Darkening, discoloration, or signs of corrosion most likely indicate past episodes of abnormal overheating.

FIGURE 5 - THE ENDS OF THE SCREWS HOLDING THE STAB SOCKET PLATES ARE VISIBLE BETWEEN THE TWO ROWS OF BREAKERS. THIS IDENTIFIES IT AS A PANEL OF THE TYPE SHOWN IN FIGURE 2-C

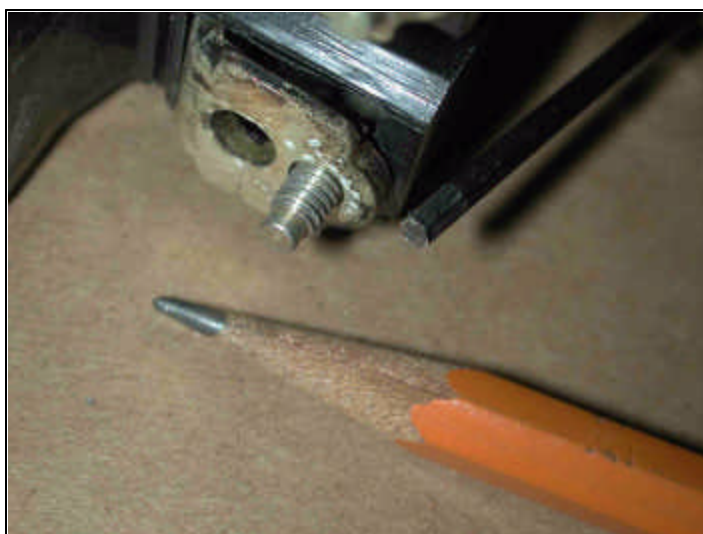
To put the diameter of the 8-32 screw in perspective, it is the same size as used on common receptacles for connecting #14 or #12 copper wire (for 15- and 20-amp circuits), and has a diameter of only about 5/32". An FPE panel and main breaker of this type is shown in Figure 6. The main breaker's output terminal mounting screws and the tiny Allen-wrench that fits them are shown in Figure 7.

FIGURE 7 - ONE LOAD-SIDE CONTACT AND ITS 8-32 CLAMPING SCREW, ON THE FPE 100-AMP MAIN BREAKER OF FIG. 6. THE SCREW-HEAD TAKES A 3/32" ALLEN WRENCH, WHICH IS ONLY SLIGHTLY LARGER THAN THE LEAD OF THE #2 PENCIL.
