Report Prepared by:
Hutchison Home Inspection Services, LLC
A. H. (Butch) Hutchison, P.E.
132 Williams & Broad Dr., Huntsville, AL 35741
256-508-9242; Alabama License # HI-0842
For
John and Sue Smith

123 Main Street
Huntsville, AL

Date of Inspection: December 11, 2006
Start Time: 10:30 AM **Finish Time:** 1:30 PM
Temperature at Time of Inspection: 61 to 65°Fahrenheit
Weather Conditions at Time of Inspection: Mostly Sunny
Estimated Days Since Last Significant Rainfall: Less Than 1 Week
Direction Front of House Faces: West NW
Occupancy Status at Time of Inspection: Vacant-New Construction

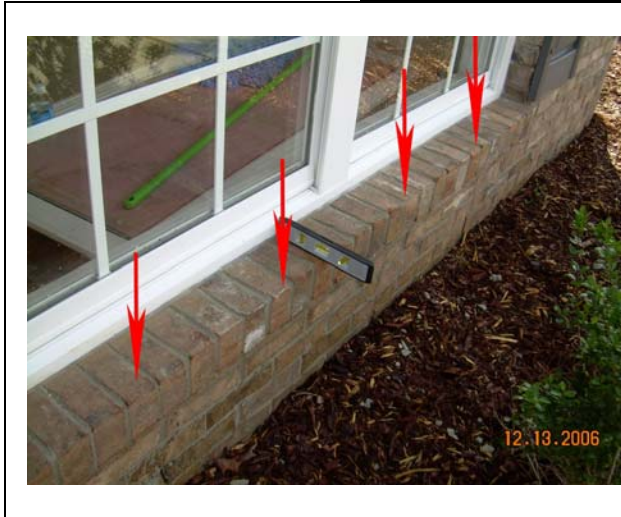
- 1.1.8. Mortar on shingles to left side of front porch should be cleaned.
- 1.2. The brick rowlock (brick laid on side with end facing out) at many of the exterior windowsills is flat to sloping back toward the house. See Figure 1 for example. The brick should slope away from house to direct water away from windows. The Brick Industry recommends a minimum slope of 15 degrees. Each windowsill should be checked and corrected as required.

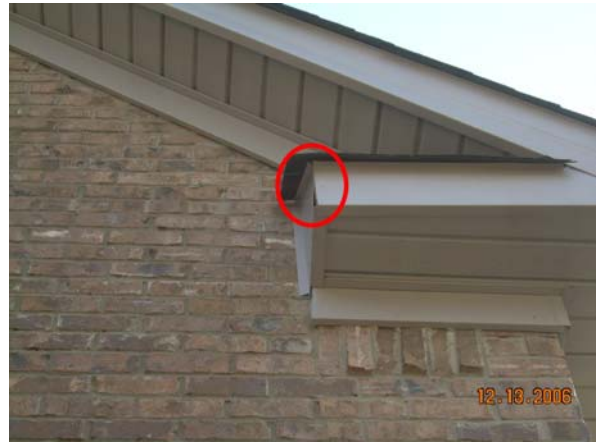
Figure 2

- 1.3. The outside corner of the fascia at the return to the left side of the front porch (see Figure 2) is open. The aluminum trim should be wrapped around this corner as with other corners.

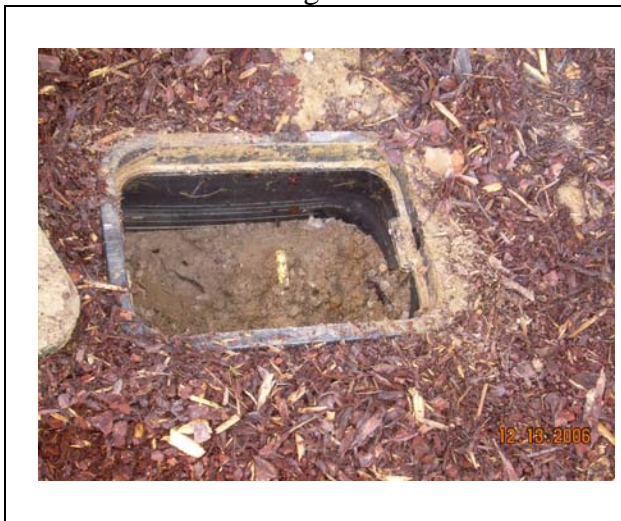
Figure 3

- 5.1. There is a water meter box located in the flowerbed to the right side of the front porch. See Figure 3. This box is assumed to contain the main water cutoff and possibly the

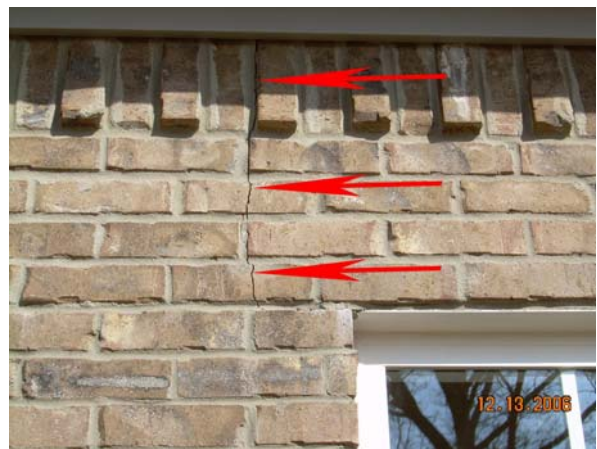
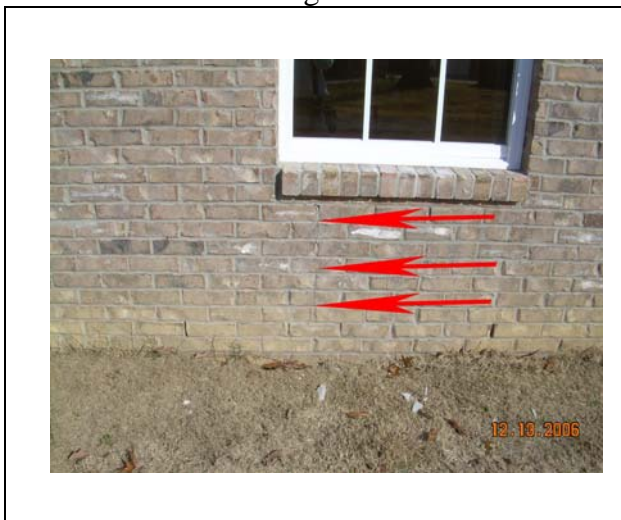
Figure 4

- 2.1. There is a vertical crack through brick and mortar above and below a window on the right side of the house. See Figures 4 and 5. The nature of this crack suggests the slab has possibly settled differentially and cracked in this area. There is no indication that further settlement will occur, but to further protect the buyer, inspector recommends a structural engineer be consulted.

Inspected	Present or N/A	Not Noted	Item	Comments
1.1.	<input checked="" type="checkbox"/>	<input type="checkbox"/>	<input checked="" type="checkbox"/>	Foundation (exterior evaluation) Checklist: Settlement, cracking, bowing, displacement, deterioration, ...	Type: Slab on Grade - Vertical cracks present in brick veneer on right side of house. This suggest possible crack in slab. See comments in Summary.

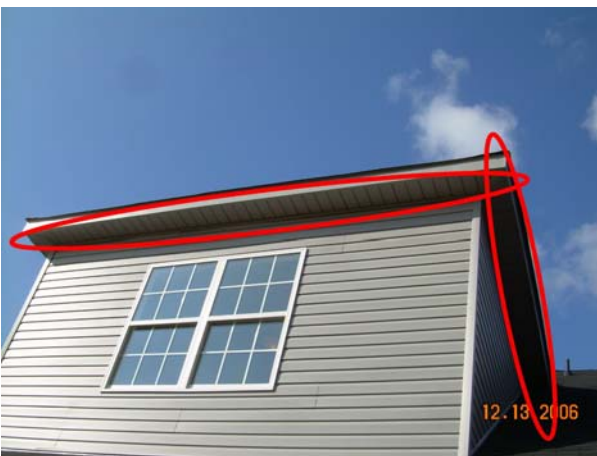
Figure 6

- 1.4. The soffit for the 2nd floor projection on back of house has no ventilation provided. See Figure 6. Soffit should be replaced with properly vented soffit.

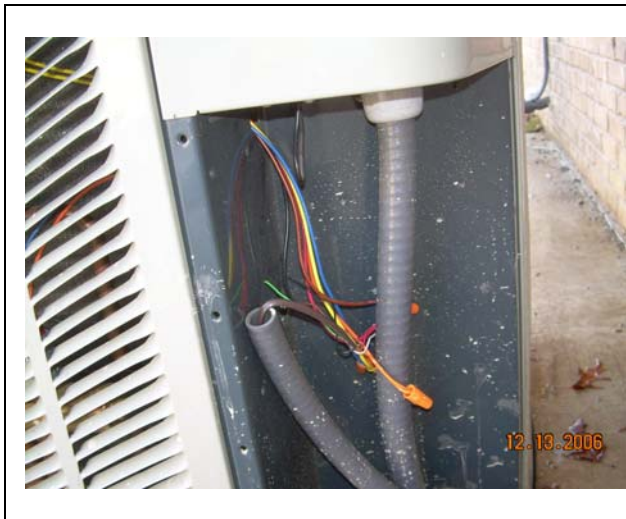
Figure 7

- 4.1. The connections for the thermostat wires are exposed at the exterior units. See Figure 7. It appears that a cover is possibly missing from units. Covers should be installed, or connections moved inside unit as required.

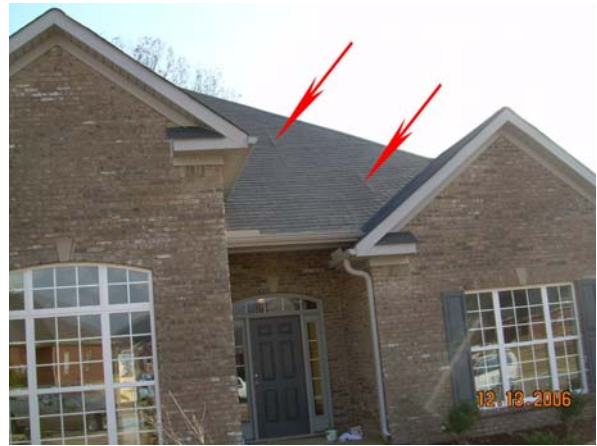
Figure 8

- 1.5. Roof issues:
 - 1.5.1. There are very noticeable ridges in the roof shingles in several locations around the house. The most noticeable are on the front roof surface to the right side of front porch (see Figure 8), and just to the backside of garage (see Figure 9). This could be caused by felt under-layment not being flat, or by decking that is not lying flat. This is distracting from the overall appearance of house and should be corrected.

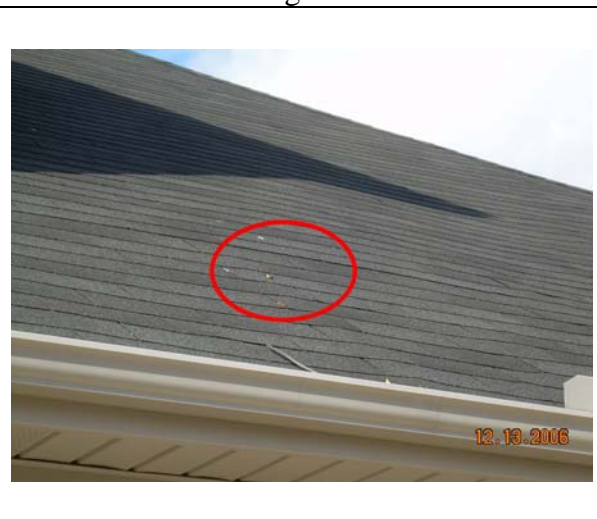
Figure 10

- 1.5.2. There are some roofing nails lying on the roof surface over the patio. See Figure 10. Should be removed.
- 1.6. The microwave is slightly loose from cabinet (moves slightly when side-to-side or front-to-back force is applied). Should be secured.

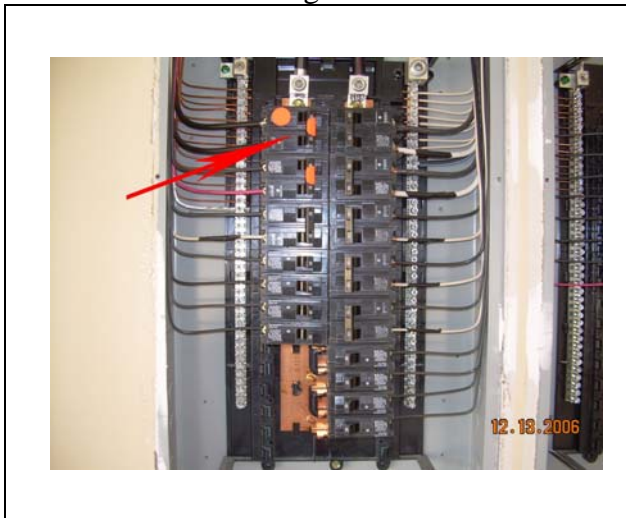
Figure 11

- 3.1.1. The 50-amp breaker (top breaker left side of left panel-labeled “Range”) is feeding #6 gauge aluminum wire. See arrow in Figure 11. Unless the insulation for this conductor is rated at 75 or 90 C (60 C rated insulation is typical for residential branch circuits), the wire is undersized for the breaker rating. #6 (60 C) gauge aluminum wire requires 40-amp breaker or less for proper over current protection. A qualified electrician should investigate and correct if required.

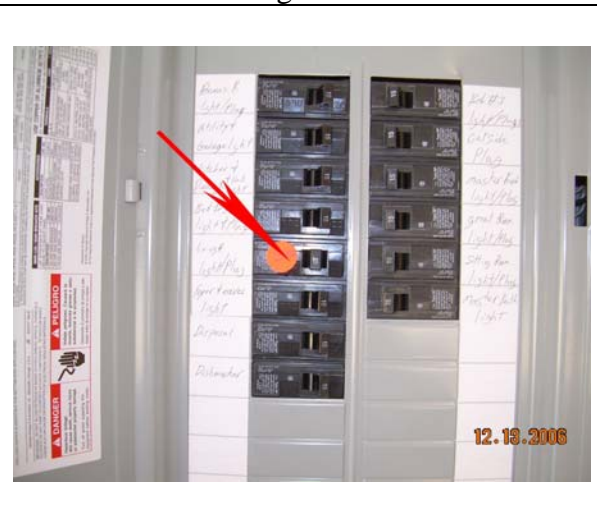
Figure 12

- 3.1.2. The circuit labeled “Living Room Light/Plug” (5th down on left side of right panel) was tripped when first observed, and tripped when reset. See Figure 12. The fault in this branch circuit should be found and corrected. This breaker actually feeds the downstairs back-left bedroom and the shared bathroom. Labeling should also be corrected. FYI - Inspector found that when the unused switch (installed for future ceiling fan) in the back-left bedroom was turned off, the breaker would reset, and would trip when this switch was turned on.

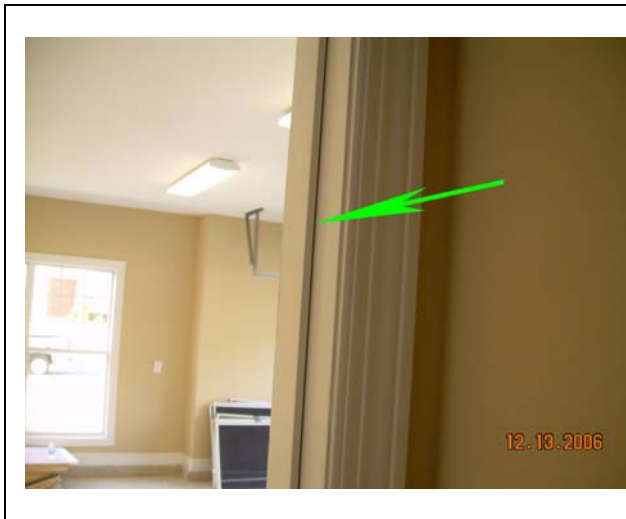
Figure 13

- 1.1.1. Weather stripping not installed around door leading to garage. See Figure 13.
 - 1.1.2. General cleanup of driveway, patio, garage, etc.
 - 1.1.3. Installation of splash blocks or drain pipes at downspouts.

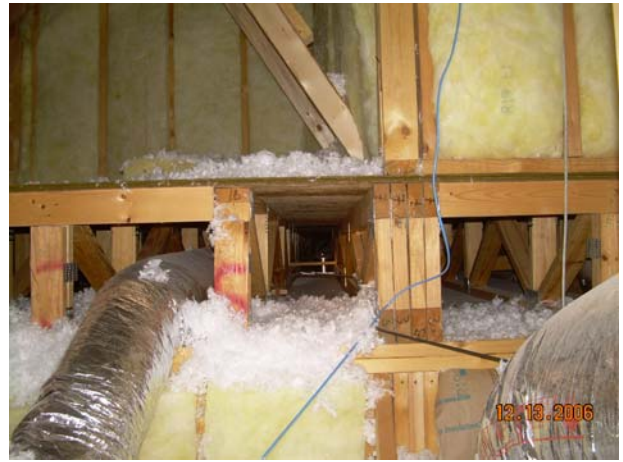
- 4.2. The space between the 1st level ceiling and 2nd level floor is open into the attic space. Figure 14 shows view from back-left corner of lower attic. These openings (on both sides of lower attic) should be blocked to prevent attic air from entering this space.

Inspected	Present or N/A	Not Problem Noted	Item	Comments
3.3.	<input checked="" type="checkbox"/>	<input type="checkbox"/>	<input checked="" type="checkbox"/>	Insulation Checklist: Presence, coverage, depth, ...	Coverage Over Heated Area: Appears complete Type: Loose fiberglass - bats against interior walls. Estimated Depth or Thickness: 12 to 15 Inches See comments in Summary Openings between ceiling and floor should be blocked.

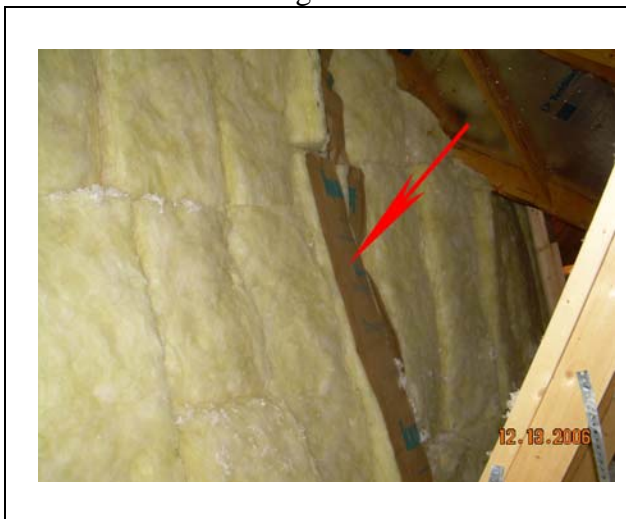
Figure 15

- 4.3. Some of the insulation batts against walls in the left side lower attic space are installed with vapor barrier facing attic. See Figure 15. Vapor barrier should face heated space. Some of the batts are not pushed completely into space between studs. Loose batts should be secured in place.
