Inspection Report

Property Address:
542 Downtown Street
Charleston, SC 29403

A to Z Home Inspections

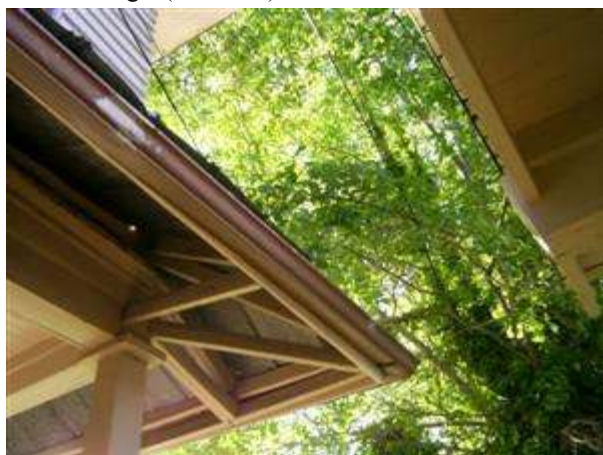
1.0 Picture 1

Roof covering is metal or tin and a metallic coating has been applied. The roof may need periodic maintenance of these coatings. (Picture 1) Tree limbs that are in contact with roof or hanging near roof should be trimmed.

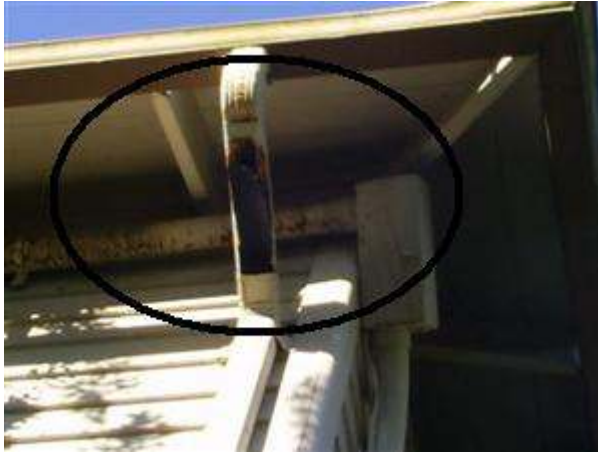
1.4 Picture 1

(Picture 1) Gutter is rusted and deteriorated in various areas throughout. Needs replacing. (Picture 2) Downspouts need elbows and splash-blocks at front, rear and sides of home. (Picture 3) Gutter needs to be tightened against home sealed at left side (facing front).

(Picture 1) Gutter is rusted and deteriorated in various areas throughout. Needs replacing. (Picture 2) Downspouts need elbows and splash-blocks at front, rear and sides of home. (Picture 3) Gutter needs to be tightened against home sealed at left side (facing front).

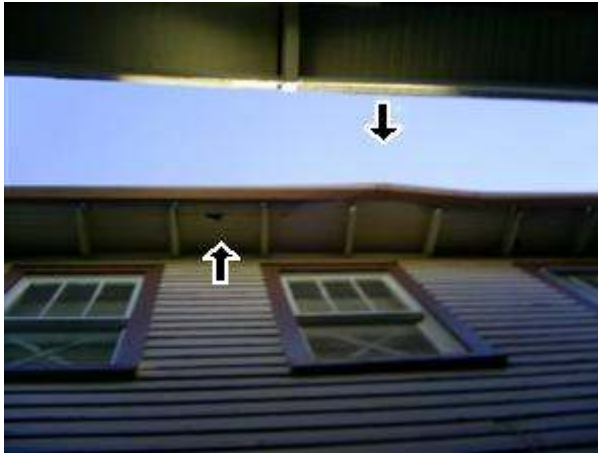
2.0 Picture 1

(Picture 1) Eave and gutter damage on side of the home. Recommend repair of the damaged areas.

(Picture 1) Eave and gutter damage on side of the home. Recommend repair of the damaged areas.

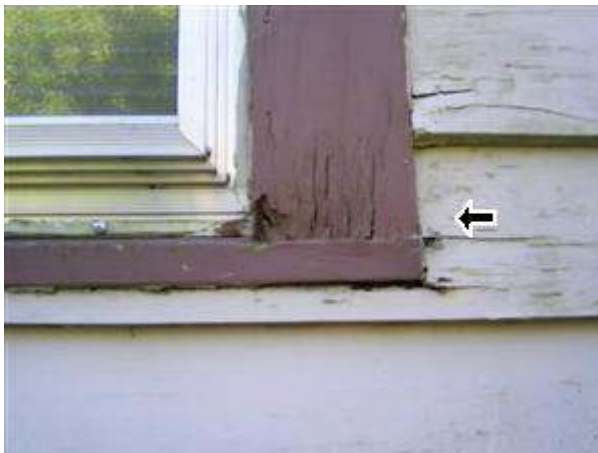
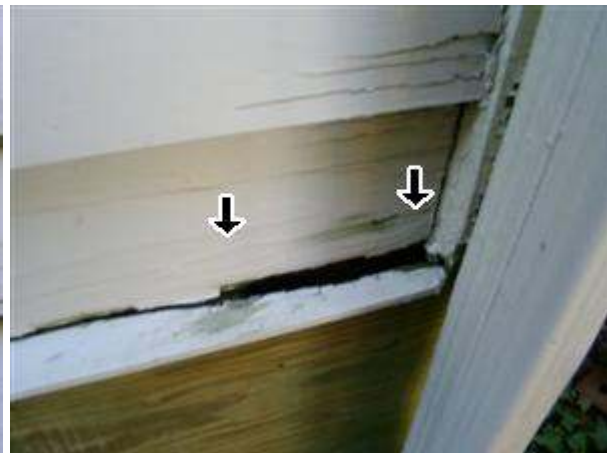
Water damaged siding in several areas of the home. Budget for repairs of these areas in the near future to preclude further deterioration.

Water damaged siding in several areas of the home. Budget for repairs of these areas in the near future to preclude further deterioration.

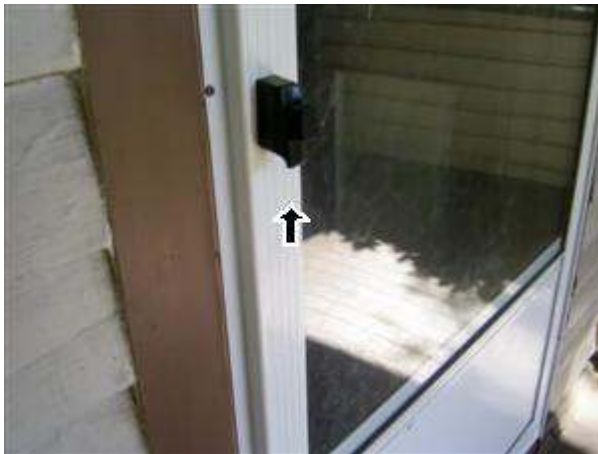
2.3 Picture 1

Broken handle on the downstairs unit storm door.

Broken handle on the downstairs unit storm door.

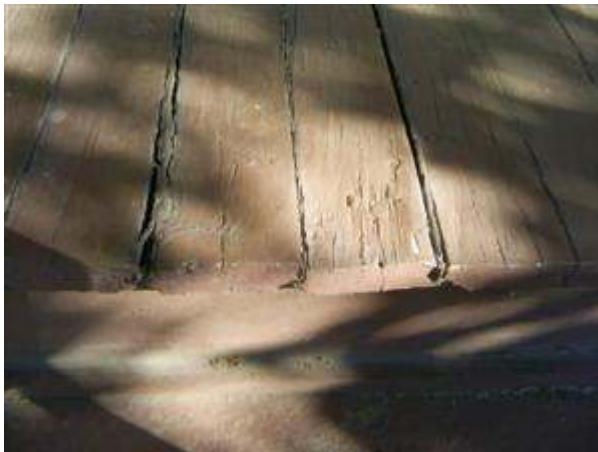
2.4 Picture 1

Wood floor decking on covered porch at front of home deteriorated. Further deterioration can occur if not repaired. Recommend repair or replace by a qualified contractor.

Wood floor decking on covered porch at front of home deteriorated. Further deterioration can occur if not repaired. Recommend repair or replace by a qualified contractor.

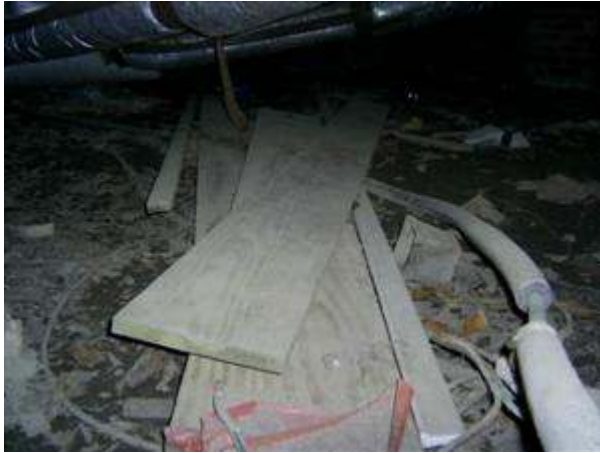
2.6 Picture 1

Lots of debris under the home. Recommend removal to help in the control of wood destroying insects.

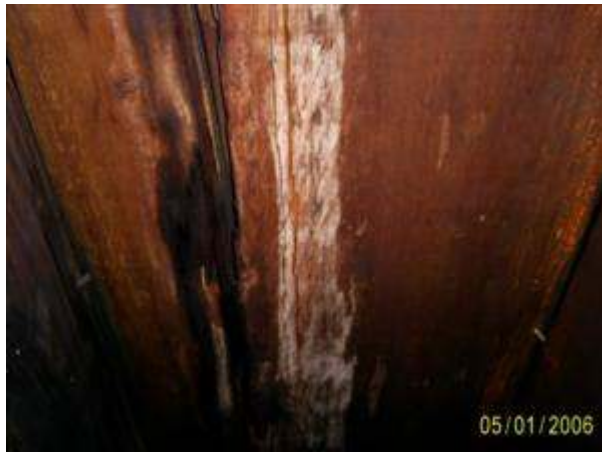
4.1 Picture 1

2x8 rafters deteriorated along valley (above Guest bedroom). Area still remains strong. Not cost effective to replace until next roof. Recommend a qualified contractor repair as needed at that time.

2x8 rafters deteriorated along valley (above Guest bedroom). Area still remains strong. Not cost effective to replace until next roof. Recommend a qualified contractor repair as needed at that time.

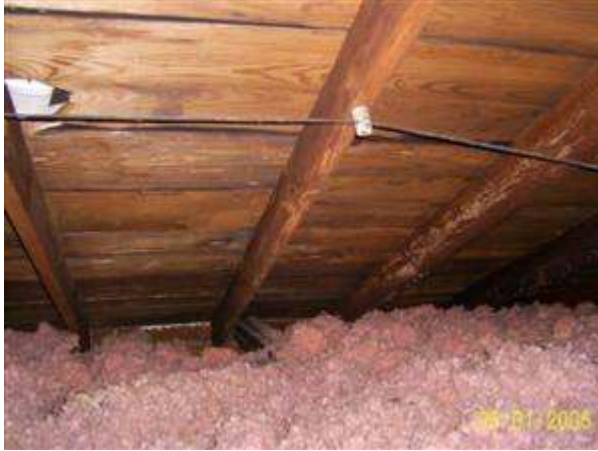
4.7 Picture 1

(Picture 1) Old knob and tube wiring still in place in the attic. Recommend removal of outdated and unused wiring.

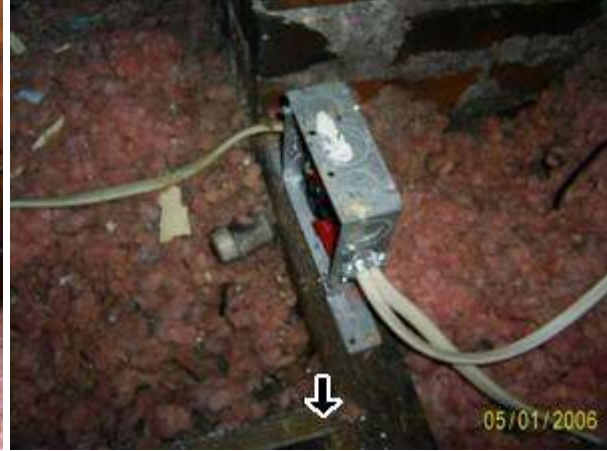
4.7 Picture 2

(Picture 2) Open junction box located too close to the scuttle hole (arrow points to opening of access) Recommend closing the box and repositioning to prevent physical damage. Recommend a licensed electrician perform all work that involves wiring.

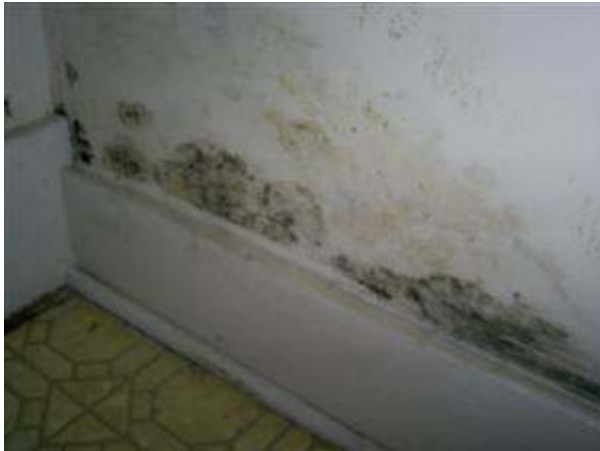
5.1 Picture 1

Signs of microbial growth present on walls along downstairs water heater room area in several areas. I did not inspect, test or determine if this mold is or is not a health hazard. The underlying cause is moisture. I recommend you contact a mold inspector or expert for investigation or correction if needed.

Signs of microbial growth present on walls along downstairs water heater room area in several areas. I did not inspect, test or determine if this mold is or is not a health hazard. The underlying cause is moisture. I recommend you contact a mold inspector or expert for investigation or correction if needed.

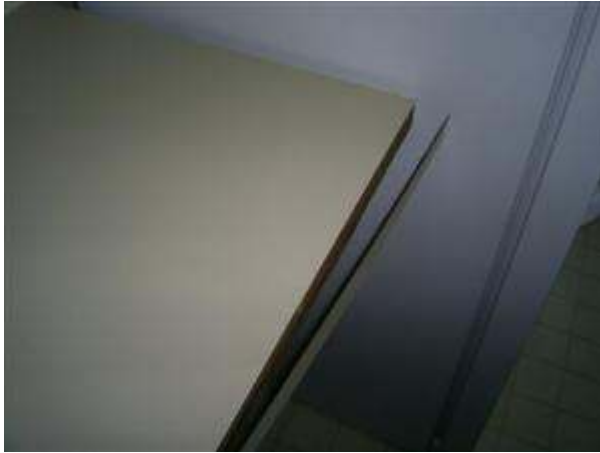
5.3 Picture 1

Laminated countertop is loose, not fastened securely at counter left of the refrigerator in down unit. This is a cosmetic issue for your information. Recommend repair or replace as necessary.

Laminated countertop is loose, not fastened securely at counter left of the refrigerator in down unit. This is a cosmetic issue for your information. Recommend repair or replace as necessary.

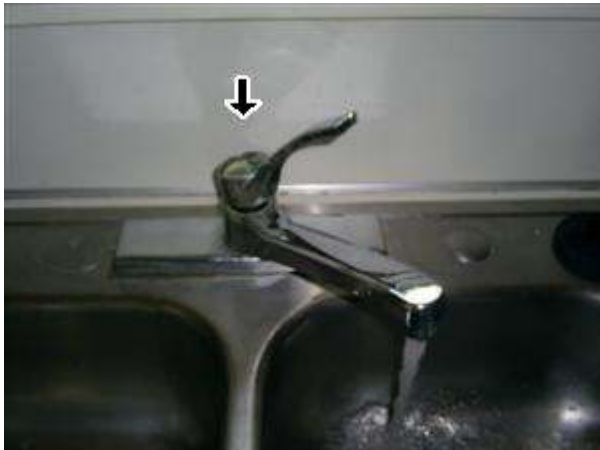
5.6 Picture 1

(Picture 1) Broken faucet top upstairs unit. (Picture 2) No rubber throat in the sink to disposal upstairs. Disposal (Kenmore) did not operate.

(Picture 1) Broken faucet top upstairs unit.(Picture 2) No rubber throat in the sink to disposal upstairs. Disposal (Kenmore) did not operate.

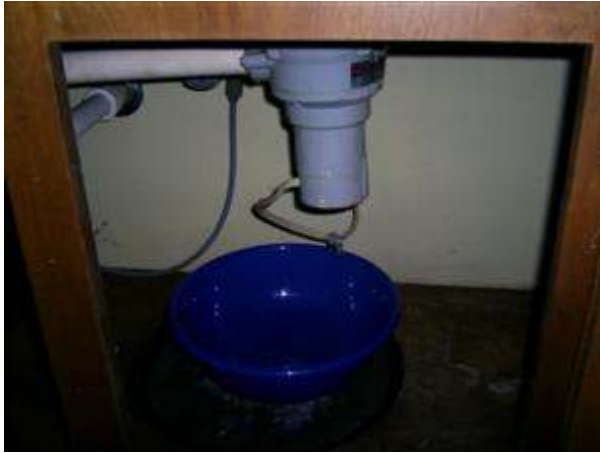
5.8 Picture 1

Disposer in the downstairs unit leaking. Recommend repair by a licensed plumber.

Disposer in the downstairs unit leaking. Recommend repair by a licensed plumber.

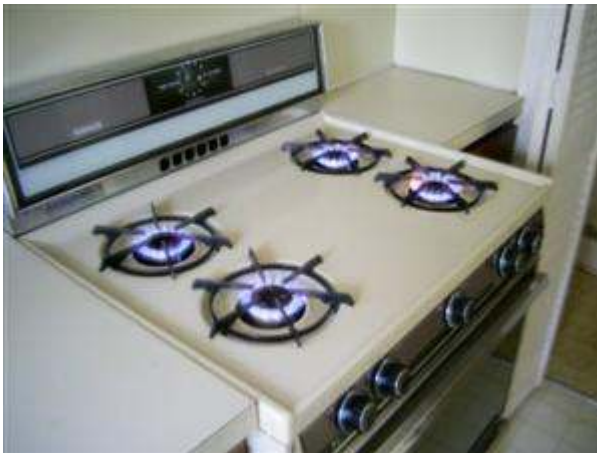
5.10 Picture 1

Comments: Inspected
Both units had cook top burners that lit. Neither oven would heat up. Recommend repair by a qualified person.

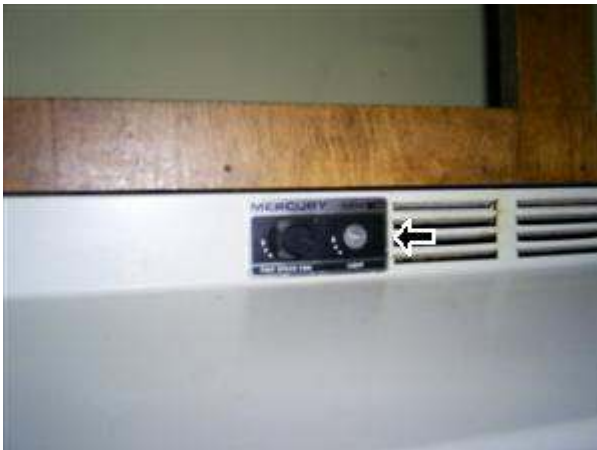
5.11 Picture 1

Comments: Inspected
Missing the light knob. Still operates okay.

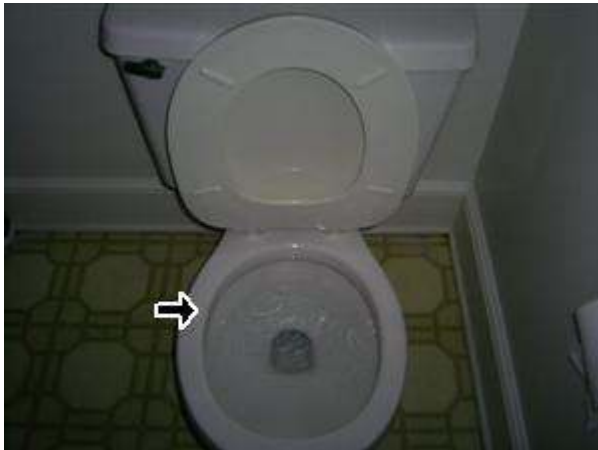
6.4 Picture 1

This toilet in the upstairs unit ran after being flushed. I turned it off with the twist valve. Recommend repair by a qualified person.

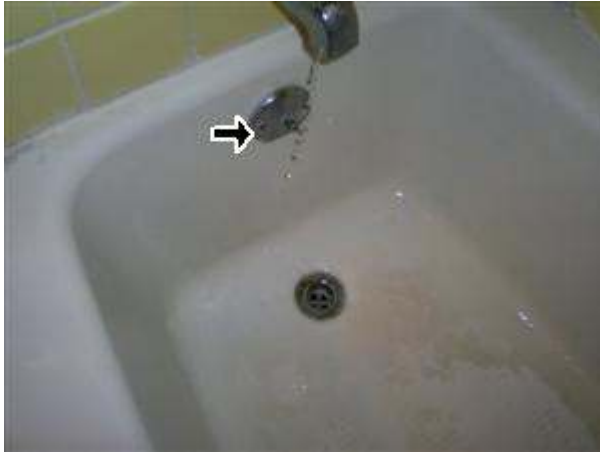
6.5 Picture 1

Stopper of the downstairs tub inoperative.

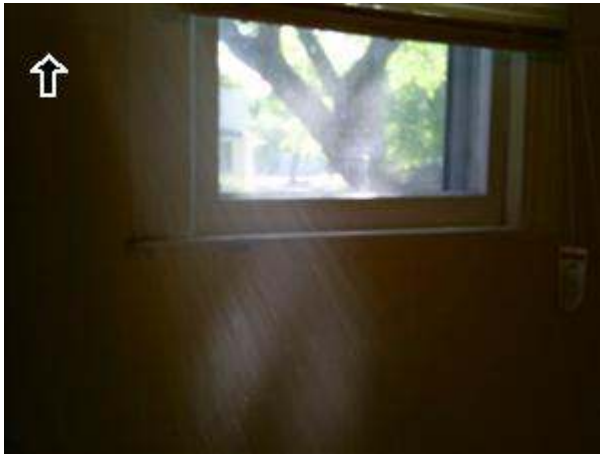
6.9 Picture 1

Shower head in the downstairs bath above the window. Water damage has occurred to this sill. Recommend raising the window above the shower line.

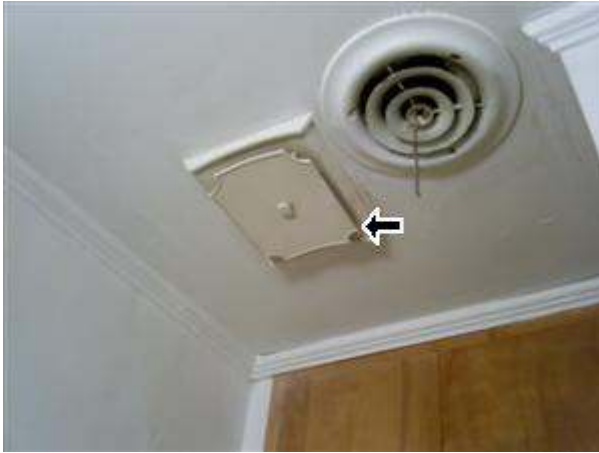
6.10 Picture 1

This vent was very weak in the upstairs unit. Recommend repair by a qualified person.

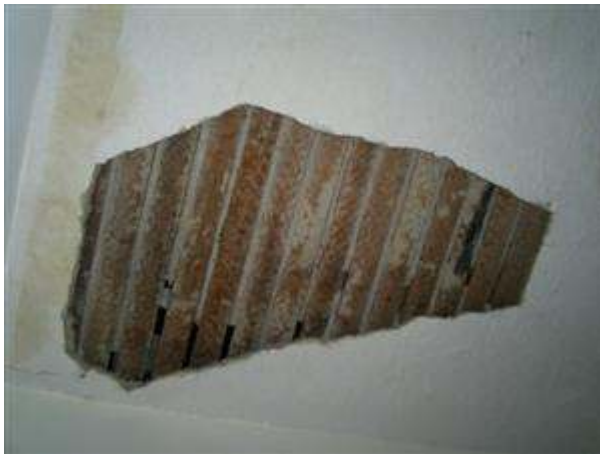
7.0 Picture 1

Plaster on ceiling is missing in areas at downstairs at hallway closet room. While this damage is cosmetic, it needs to be repaired. Recommend repair or replace as needed using a qualified person.

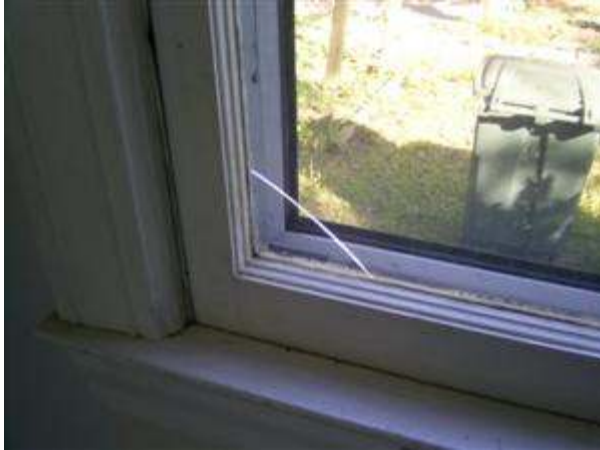
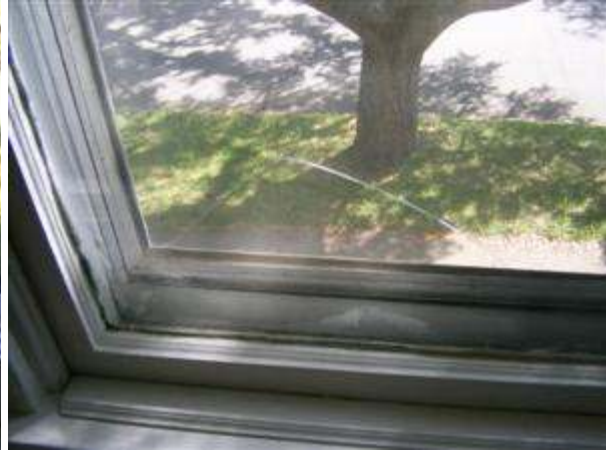
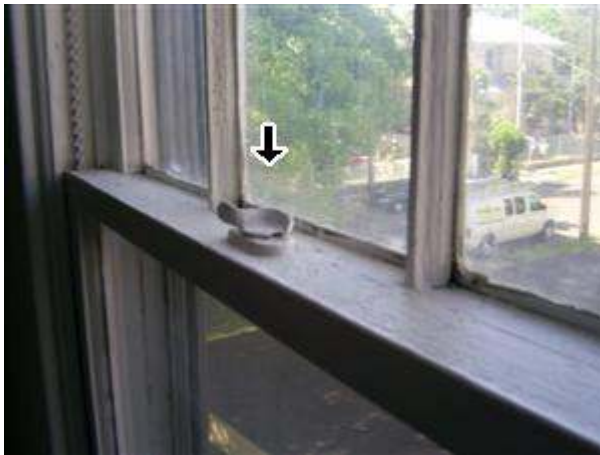
There are cracked glass in some windows throughout home.(Picture 3) Some windows upstairs missing the lock latch.

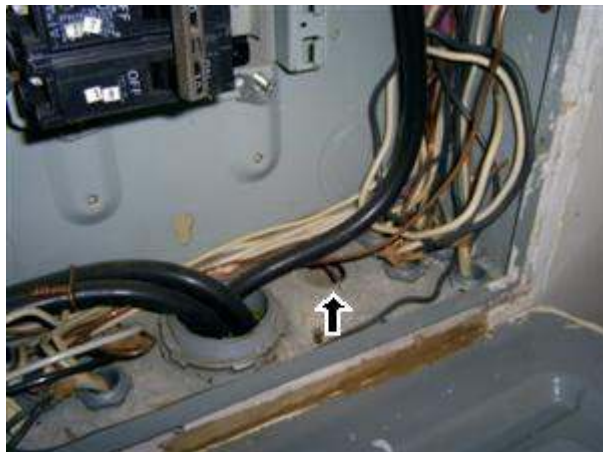
8.1 Picture 1

Problem(s) discovered in panel such as (Picture 1) amateur wiring installation, (Picture 2) ganged neutrals and (Picture 3) neutrals being used as a 'hot' (not labeled) and any other problems that an electrician may discover while performing repairs need correcting. Recommend a licensed electrician inspect further and correct as needed.

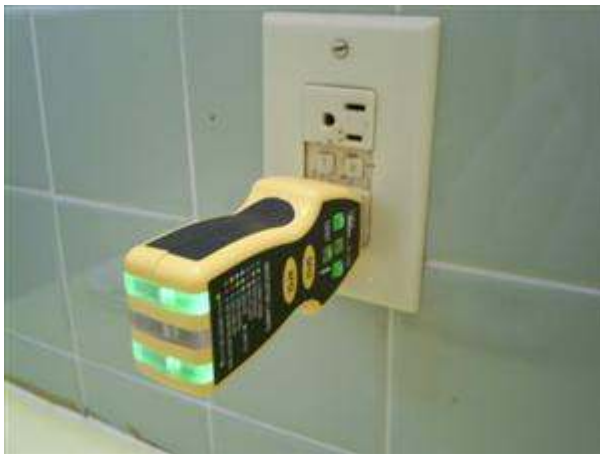
8.5 Picture 1

(Picture 1) This GFCI in the upstairs bath did not trip.(Picture 2) This GFCI in the upstairs powder did not trip (likely tied to the bathroom that was inop)

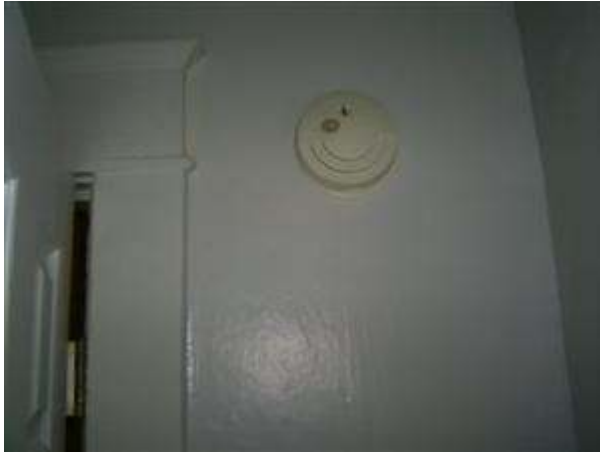
8.8 Picture 1

Would not test in the downstairs unit. Only 3 of the upstairs tested okay (battery beeping on one of them). Recommend repair or replacement of all the smoke detectors.

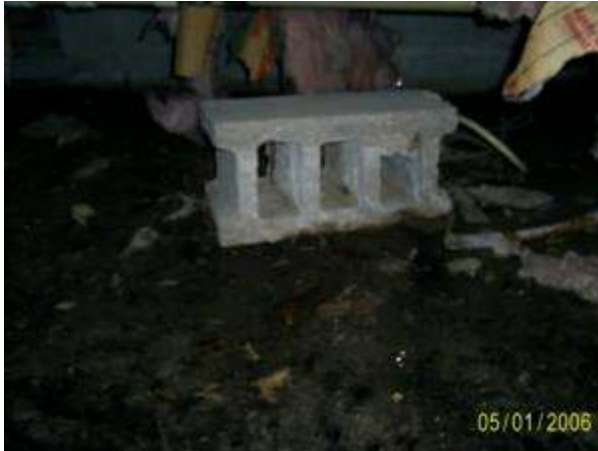
9.0 Picture 1

Long standing water present from a leak below and toward the rear of the lower kitchen.(Picture 2) Leak in the PB piping (drips in the air and along the pipe) ongoing. Recommend repair by a licensed plumber.

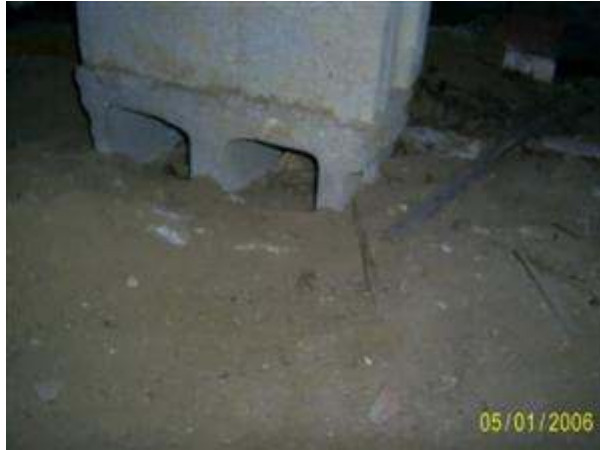
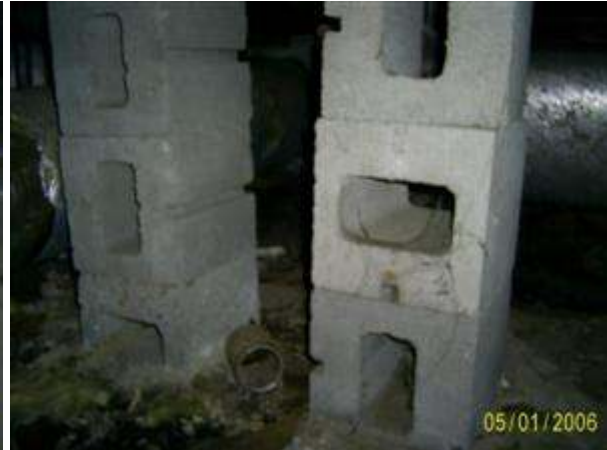
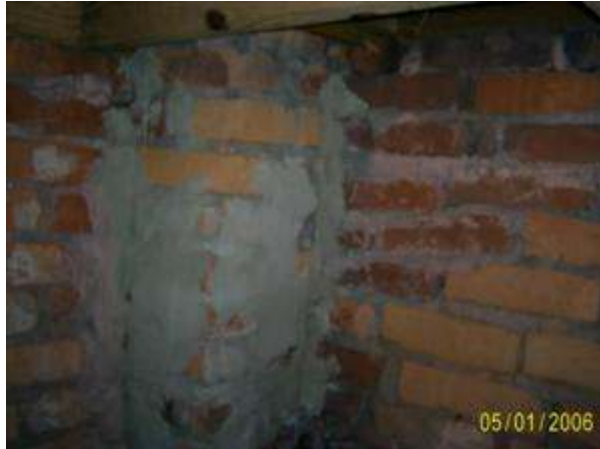
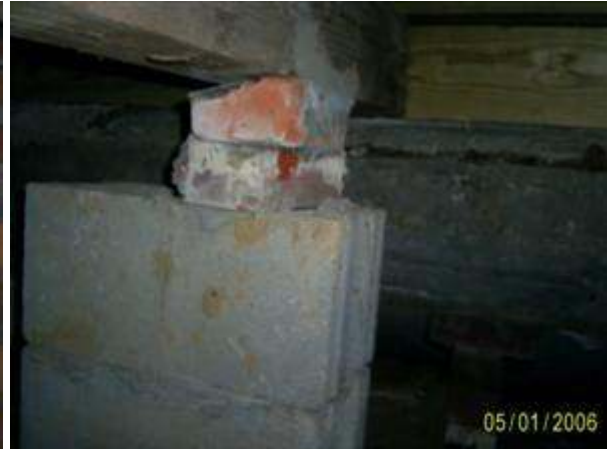
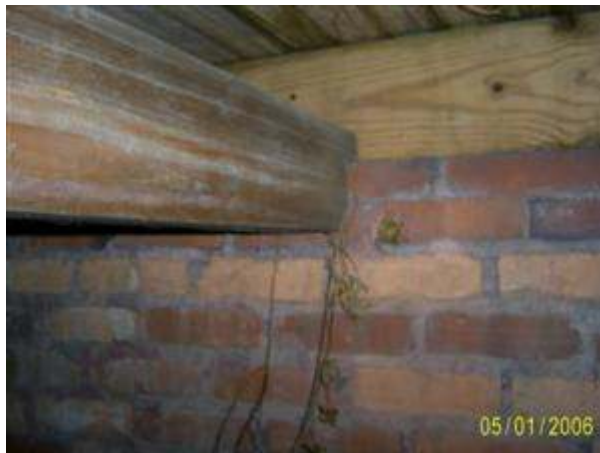
(Picture 1) (Picture 2) Several of the concrete block reinforcement piers were installed incorrectly. Original piers are still in place and still appear to be supportive as well. (Picture 3) Repaired area front left corner of the home. (Picture 4) Questionable support at the pier toward the middle of the porch area. (Picture 5) Good rim joist repair and ledger at the front of the home.

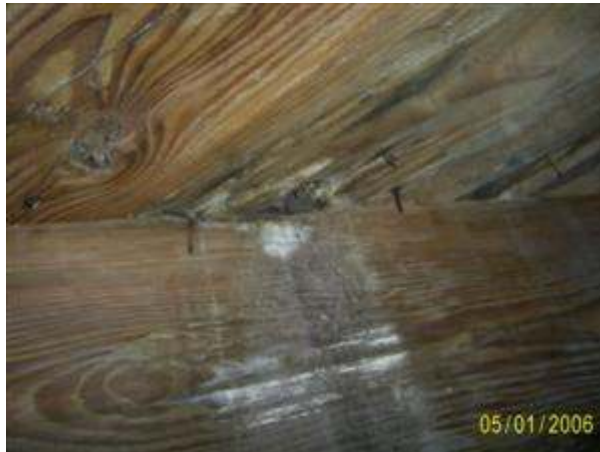
9.3 Picture 1

A couple areas of subfloor and the nearest joist shows signs of either water damage or damage by some other organism. This area is still hard or no longer actively leaking. Some of these areas may be candidates for replacement during renovations.

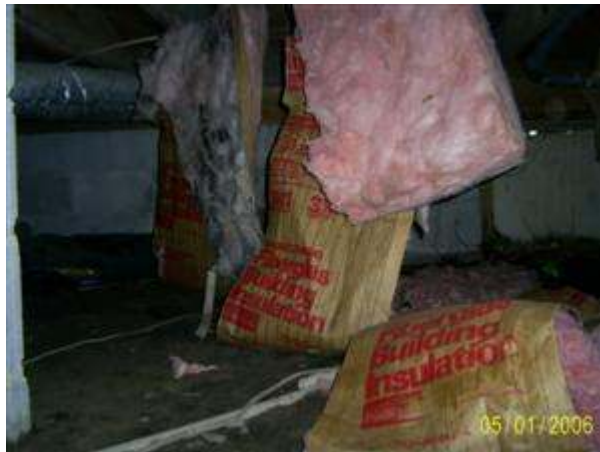
9.5 Picture 1

(Picture 1) Wet insulation hanging down toward the rear of the home. (Picture 2) Shows insulation incorrectly installed in several areas under the home. Kraft facing should be installed 'toward the heated area' not toward the ground. Vapor barrier (plastic) on crawlspace ground is missing. A vapor barrier provides added protection to floor system from moisture or dampness that can enter from ground. Recommend repair or replace as needed using a qualified person.

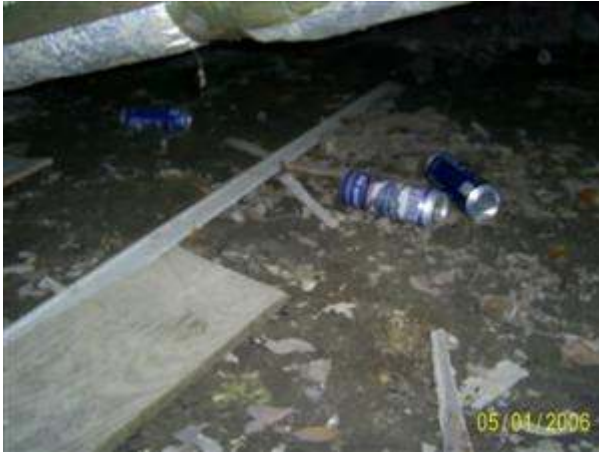
9.7 Picture 1

Some 'recyclables' left by the HVAC technicians near the crawl space air handler.

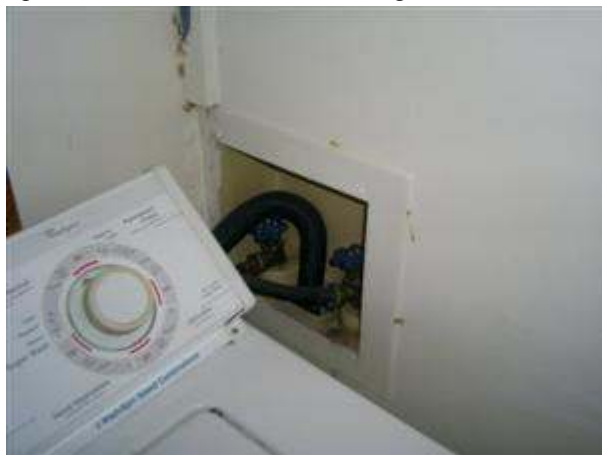
10.0 Picture 1

(Picture 1) Recommend replacement of the rubber washer hoses with braided steel hoses which are less likely to rupture and cause severe water damage to the home.

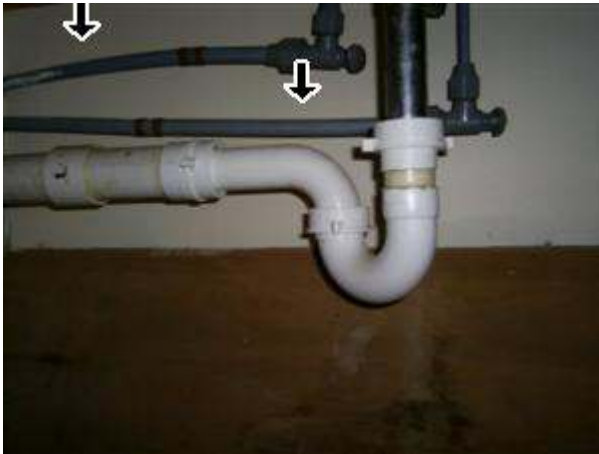
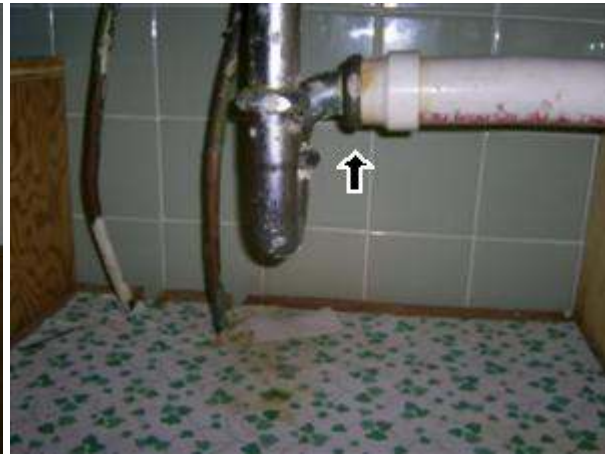
Polybutylene plastic plumbing supply lines (PB) are installed in the subject house. Polybutylene has been used in this area for many years, but has had a higher than normal failure rate, and is no longer being widely used. Copper and Brass fittings used in later years have apparently reduced the failure rate. This subject house has copper fittings and brass fittings. For further details contact the Consumer Plumbing Recovery center at 1-800-392-7591 or the web at <http://www.pbpipe.com> (Picture 2) Galvanized to PVC union not leaking at this time. Monitor this area for leaks.

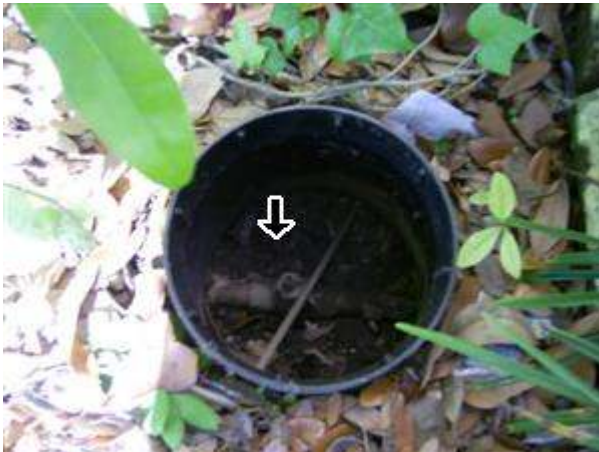
10.4 Picture 1

In front of the home. No knob (or lever) to actuate.

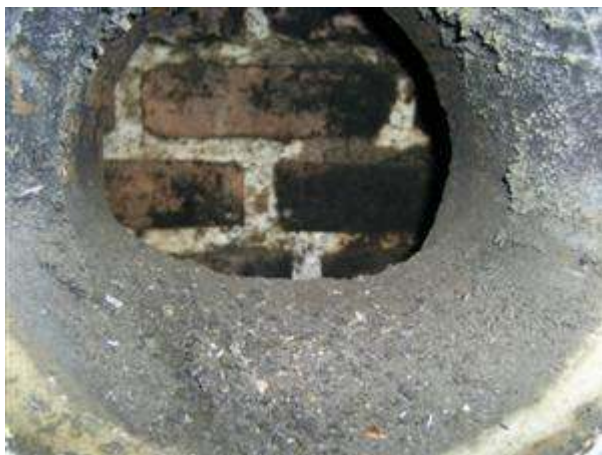
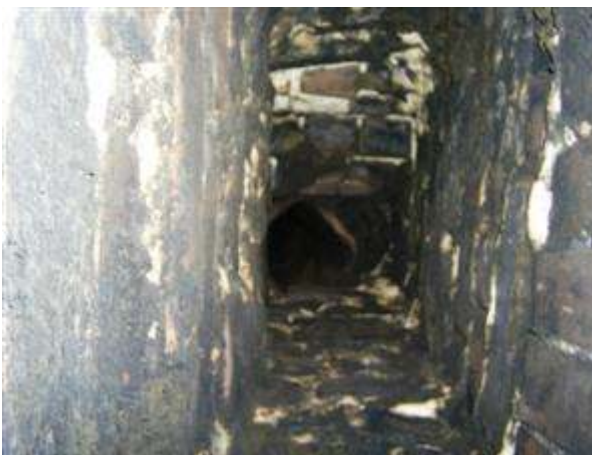
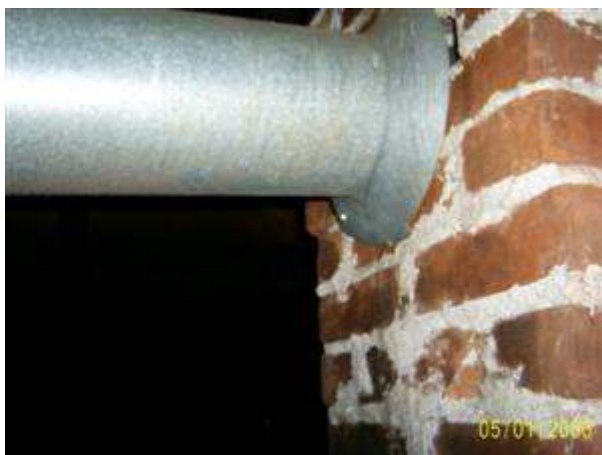
There are a wide variety of chimneys, which represent an even wider variety of interrelated components that comprise them. However, there are three basic types: single-walled metal, masonry, and pre-fabricated metal ones that are commonly referred to as factor-built ones. Single-walled metal ones should not be confused with factory-built metal ones, and are rarely found in residential use, but masonry and factory-built ones are a commonplace. My inspection of them is that of a generalist, not a specialist, and meets industry standards. However, significant areas of chimney flues cannot be adequately viewed during a field inspection, as has been documented by the Chimney Safety Institute of America, which reported in 1992: 'The inner reaches of a flue are relatively inaccessible, and it should not be expected that the distant oblique view from the top or bottom is adequate to fully document damage even with a strong light.' Therefore, because my inspection of chimneys is limited to those areas that can be viewed without dismantling any portion of them, and does not include the use of specialized equipment, I can not guarantee their integrity and recommend that they be video-scanned before the close of escrow.

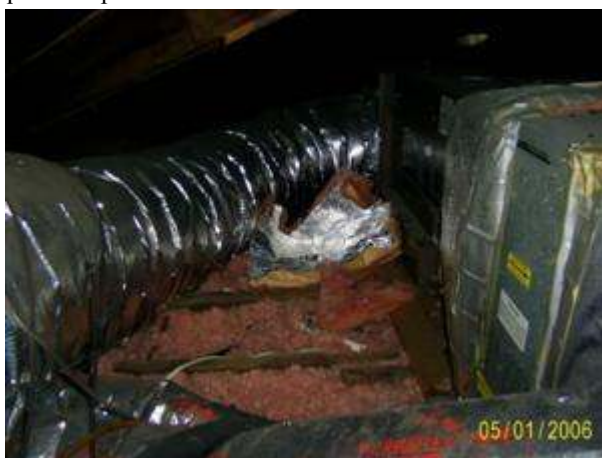
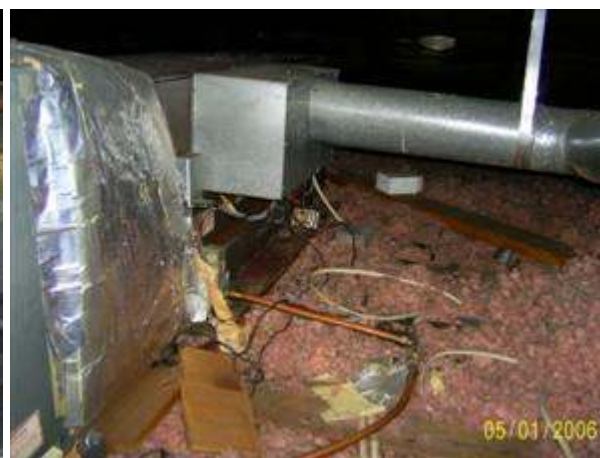
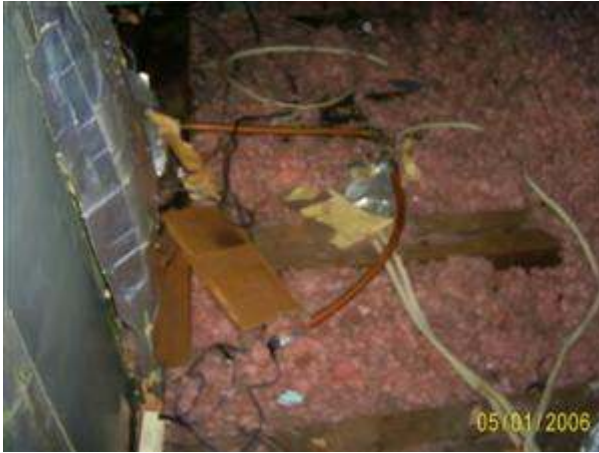
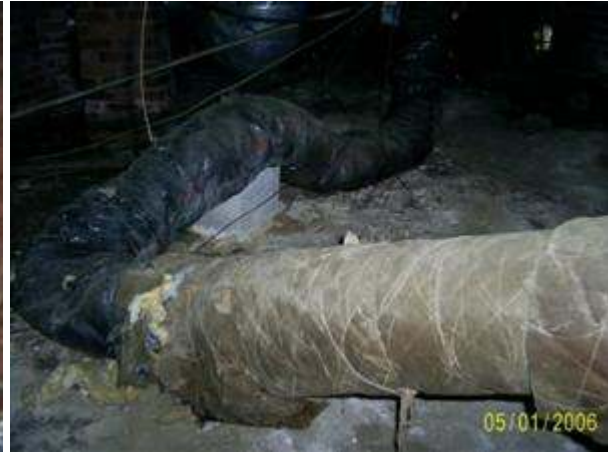
Debris all over the air handler unit in the attic. Recommend installer (if it can be determined who it was) clean the area up (regardless of any warranty) (Picture 4) This ductwork is laying on the ground. Recommend repair and support by a qualified person.

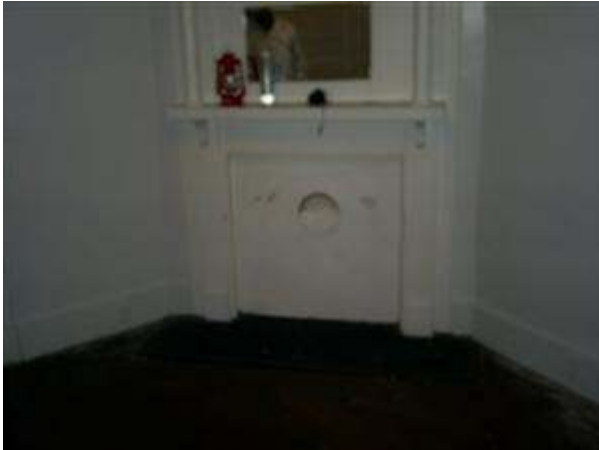
11.6 Picture 1

Currently closed off in the downstairs unit.
