J. ARONSTEIN

HAZARDOUS FPE CIRCUIT BREAKERS AND PANELS

(Updated as of May 25, 2007)

Information for Inspectors and Homeowners

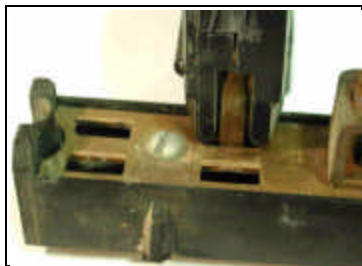
A. Copper buss bar with punched openings.
